NASA TM X-1910

FLIGHT TEST OF HIGH-DENSITY
PHENOLIC-NYLON ON A SPACECRAFT
LAUNCHED BY THE PACEMAKER
VEHICLE SYSTEM

by William G. Witte

Langley Research Center

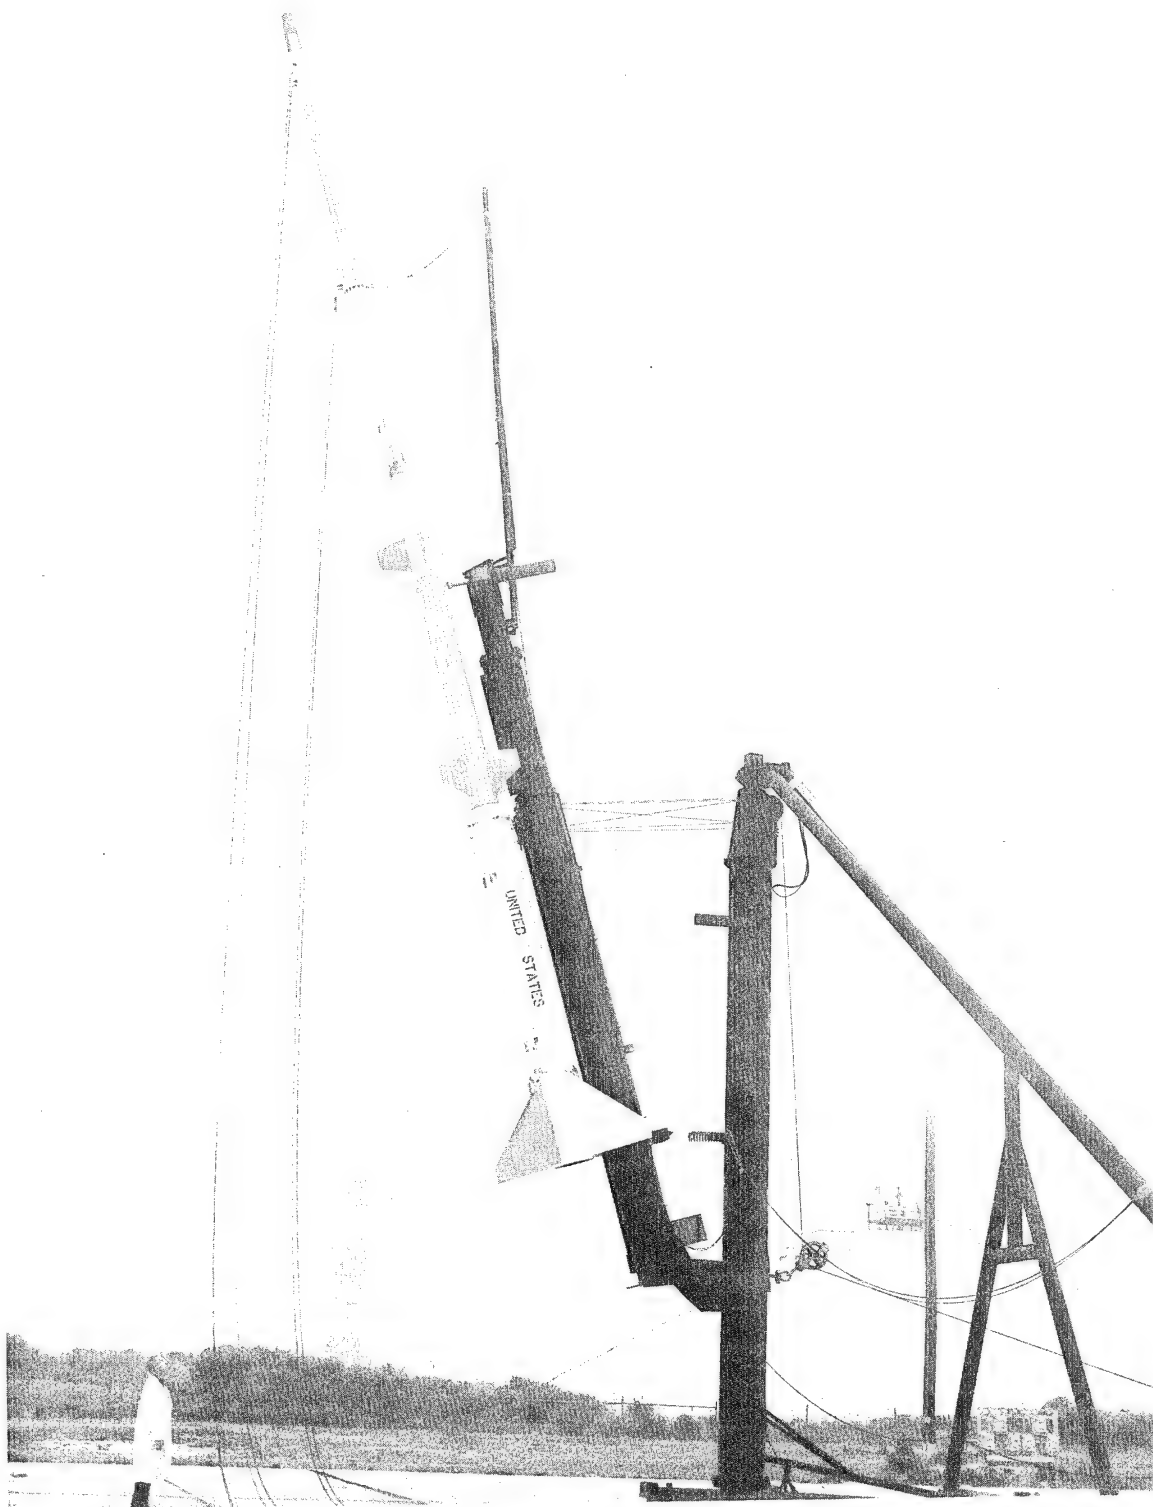
L-68-4513

Figure 4.- Photograph of the spacecraft on the launch vehicle.

The Pacemaker launch vehicle and spacecraft in launch position are shown in figure 4. The vehicle was launched June 27, 1968, from the NASA Wallops Station launch facility. It was launched at an elevation angle of 73.3° on an azimuth of 147° .
